UNITED STATES ENVIRONMENTAL PROTECTION AGENCY

Date of Inspection: August 20-23, 2012

RCRA CORRECTIVE ACTION INSPECTION REPORT

FORMOSA PLASTICS CORPORATION
201 Formosa Drive, Point Comfort, TX 77978
(EPA ID Number: TXT490011293)

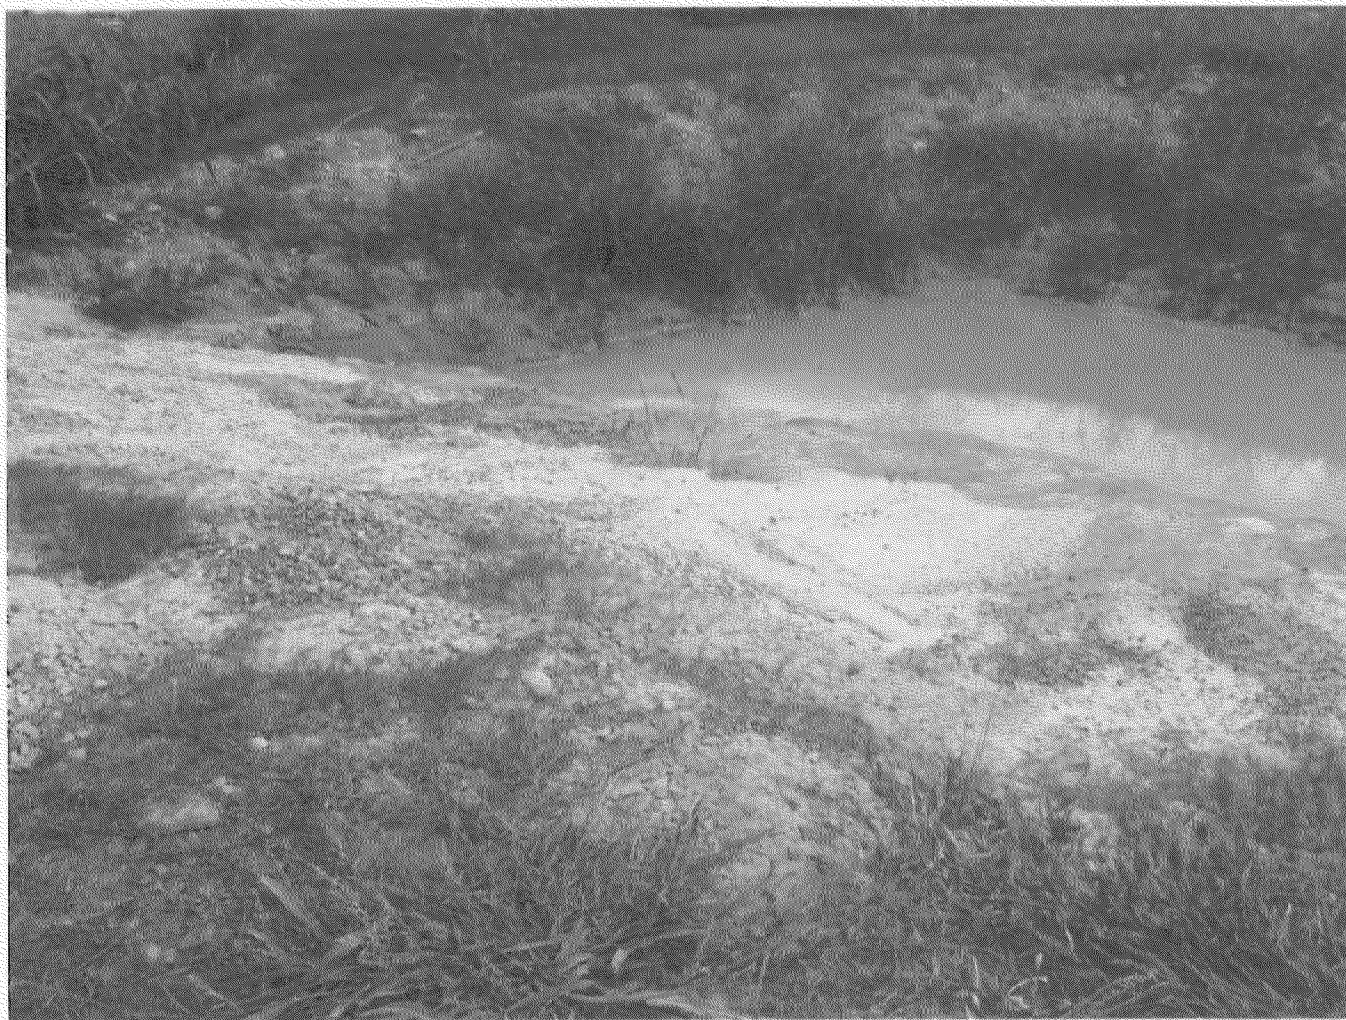
Official Photograph Log
Photo No. 1

1. AOC 2 is the construction Soil Pile, located northeast of the new Specialty Poly Vinyl Chloride (SPVC) Plant. According to Mr. Brogger, the Soil Pile was started approximately 2009 and was estimated to be approximately 4 acres in size. The soil came from the construction area for the SPVC Plant. The Soil Pile contained concrete and soil debris. A concrete washout pond was observed (see Attachment B, Photograph 1). According to Mr. Brogger, once the concrete has hardened, it is removed from the pond and placed on the Soil Pile. Formosa plans to hire a concrete crusher to crush the concrete rubble and re-use the crushed concrete for road base and riprap. Formosa has established a second soil pile located approximately 200 feet south of AOC 2 for storage of soils removed from the construction area for the new Frac II expansion project.

Photographer: Matt Brogger	Date: 8/21/12	Time: 1100 hours
City/County: Point Comfort, Calhoun	Direction (facing): North	State: TX
Location: Formosa Plastics Corp.		
Subject: Concrete washout pit at Soil Pile (AOC 2)		
Photo ID: IMG-1001 (Canon SureShot A510, #S28099)

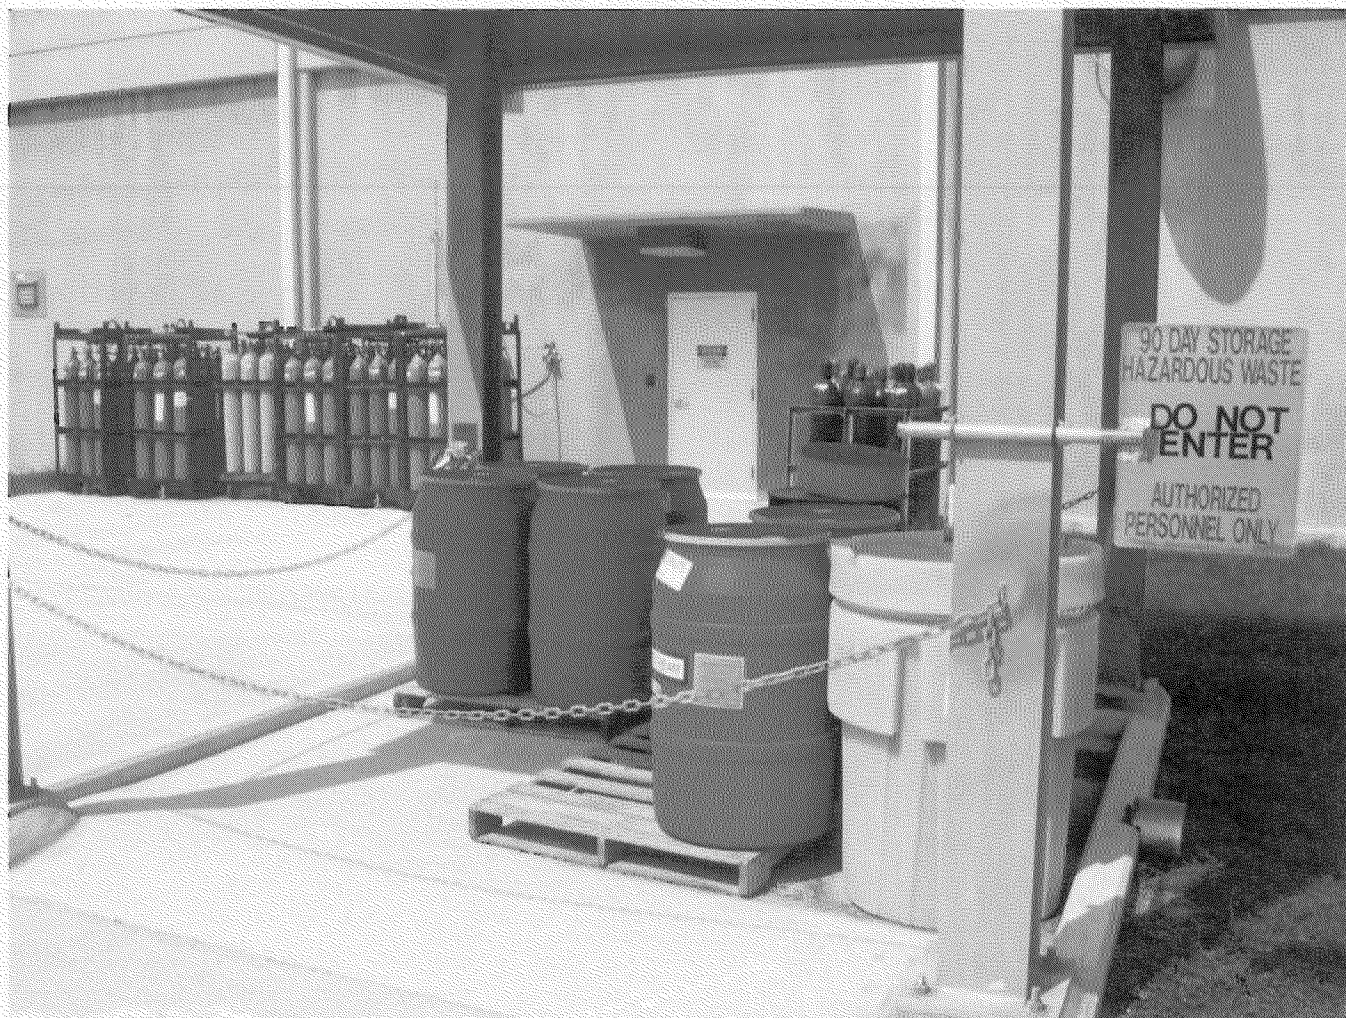
Official Photograph Log
Photo No. 2

Photographer: Matt Brogger	Date: 8/21/12	Time: 1112 hours
City/County: Point Comfort, Calhoun	Direction (facing): West	State: TX
Location: Formosa Plastics Corp.		
Subject: SPVC Container Storage Area (SWMU 11)		
Photo ID: IMG-1002 (Canon SureShot A510, #S28099)

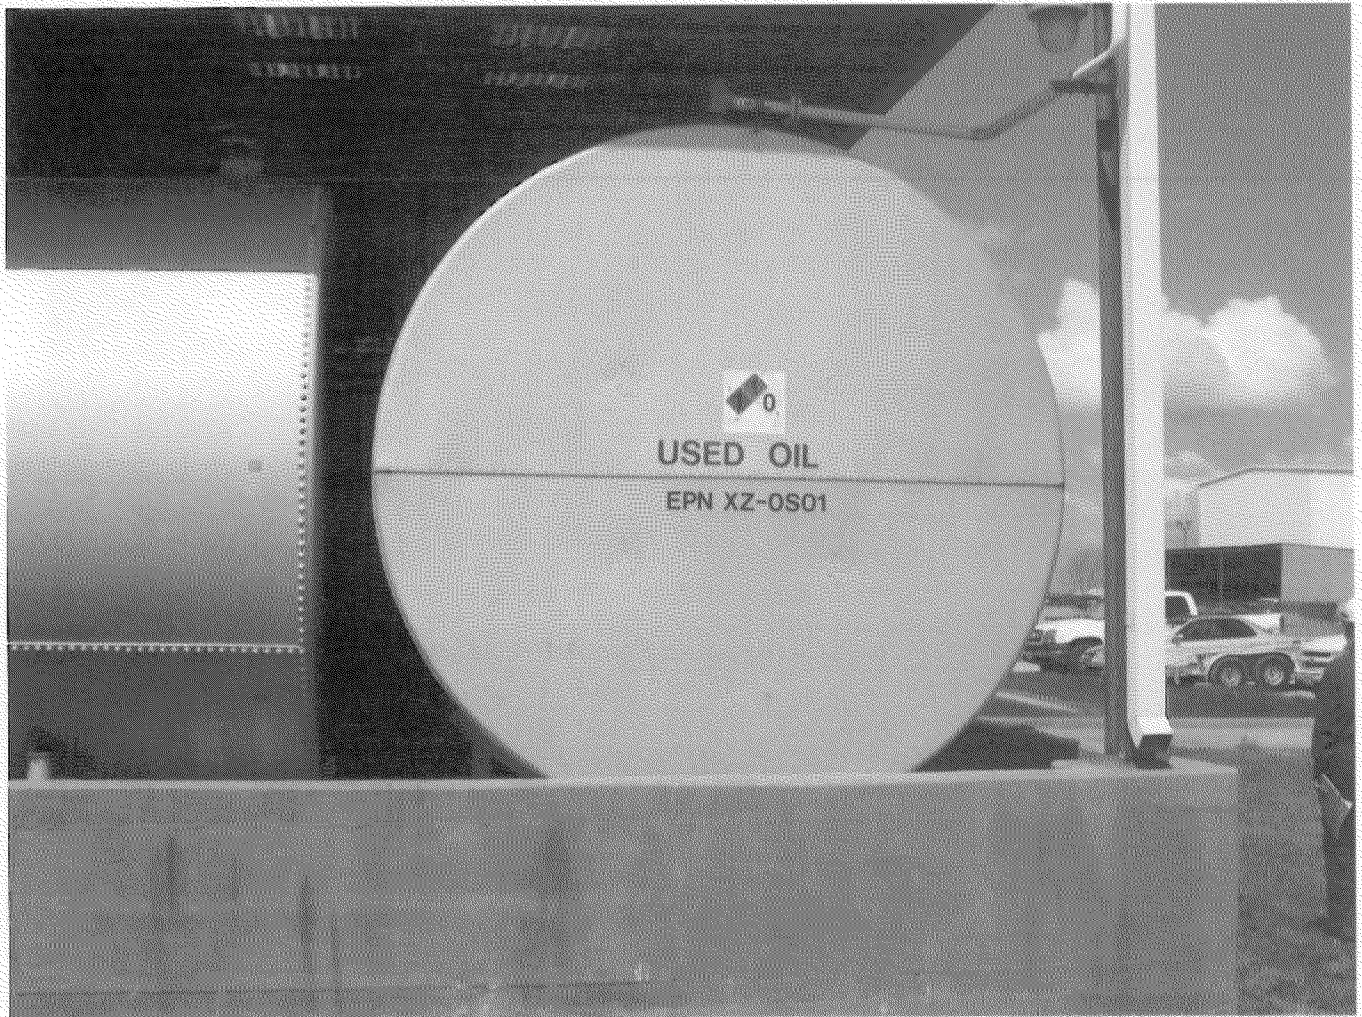
Official Photograph Log
Photo No. 3

Photographer: Matt Brogger	Date: 8/21/12	Time: 1125 hours
City/County: Point Comfort, Calhoun	Direction (facing): West	State: TX
Location: Formosa Plastics Corp.		
Subject: Used oil storage tank and secondary containment area (AOC 6)		
Photo ID: IMG-1003 (Canon SureShot A510, #S28099)

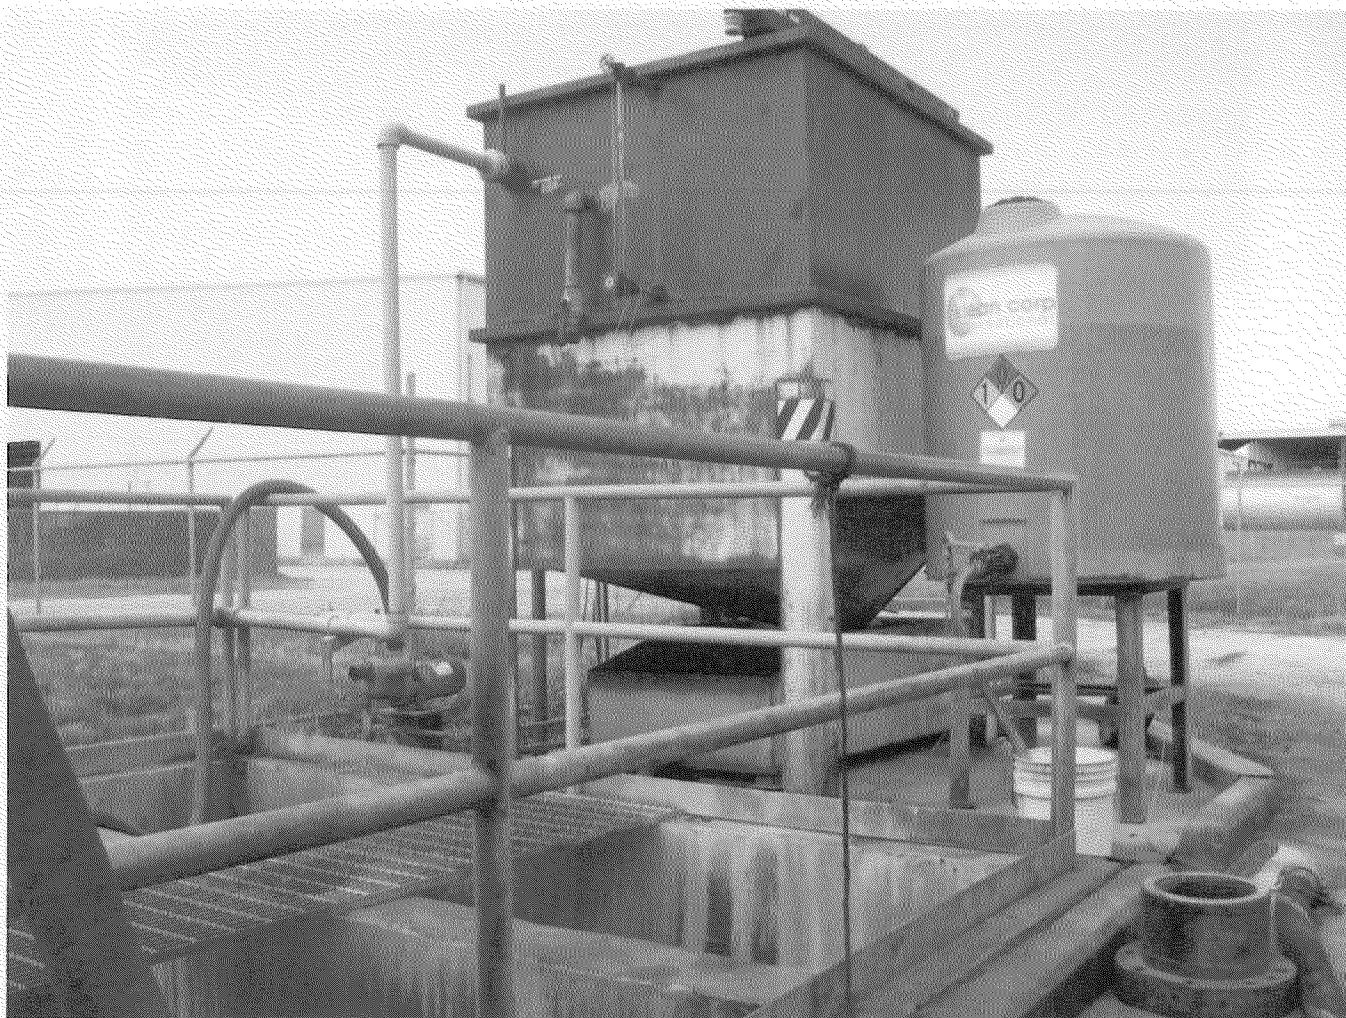
Official Photograph Log
Photo No. 4

- b. The Wash Pad is a concrete drive that has approximately 3-inch ramped berms on three side and the approximately 6-inch, raised concrete edge of the oil water separator to capture any leaks or drips during transfer of oily wastewaters to the oil-water separator (see Attachment B, Photograph 4).

At the time of inspection, EPA noted an area of concern of stained soil in a drainage path flowing from the Wash Pad outside of the bermed area along the southwest corner of Wash Pad.

Photographer: Matt Brogger	Date: 8/21/12	Time: 1130 hours
City/County: Point Comfort, Calhoun	Direction (facing): Southwest	State: TX
Location: Formosa Plastics Corp.		
Subject: Oil/water separator and pit (AOC 6)		
Photo ID: IMG-1004 (Canon SureShot A510, #S28099)

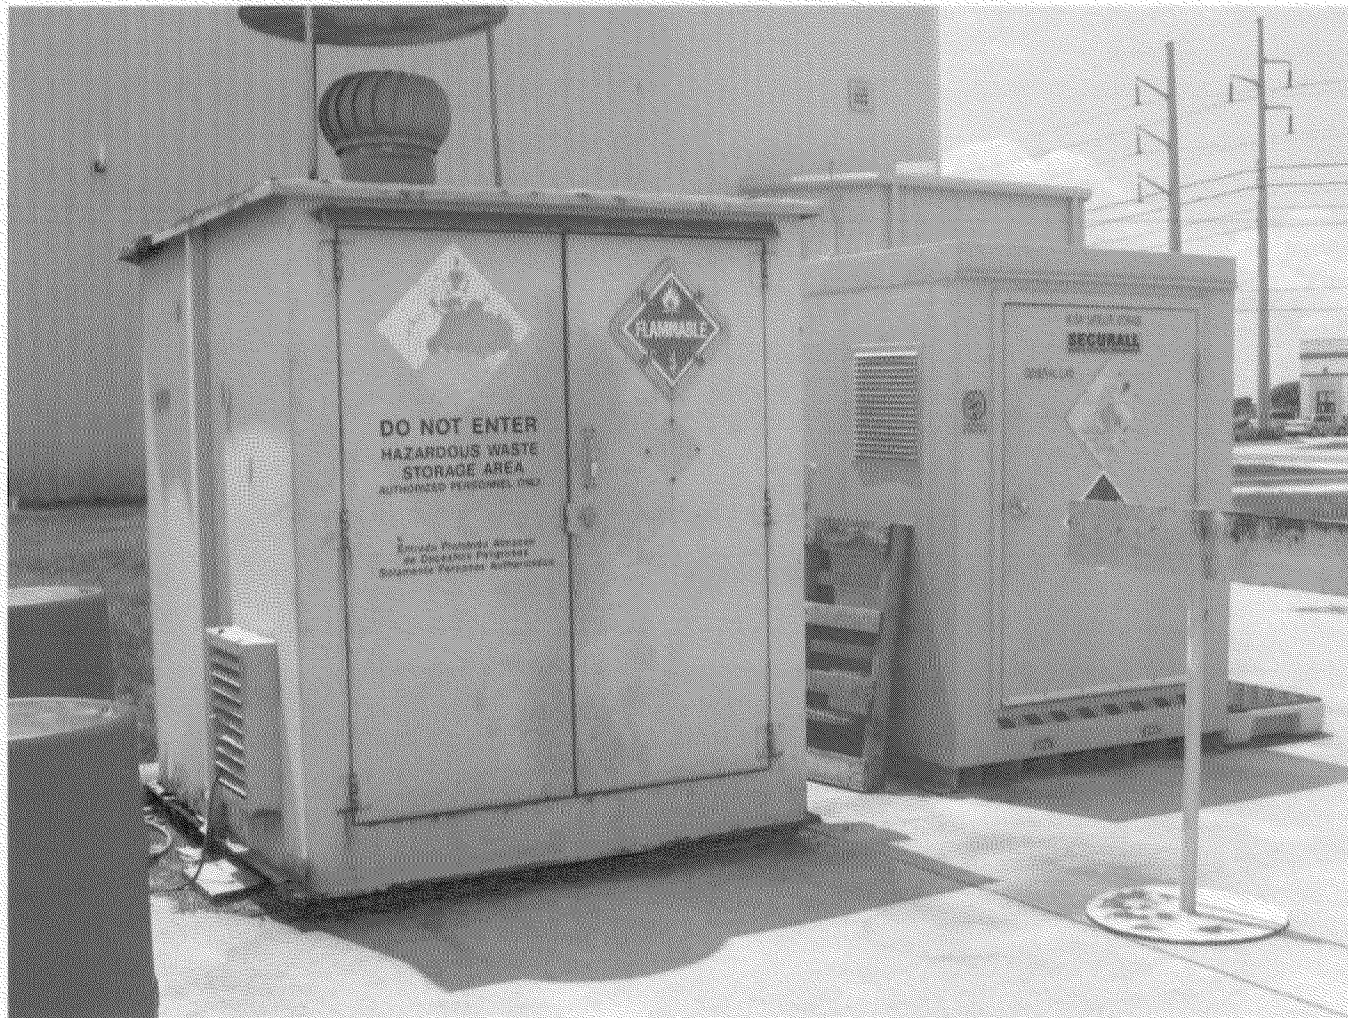
Official Photograph Log
Photo No. 5

Photographer: Matt Brogger	Date: 8/21/12	Time: 1308 hours
City/County: Point Comfort, Calhoun	Direction (facing): Southwest	State: TX
Location: Formosa Plastics Corp.		
Subject: Less than 90-day CSA at Technical Laboratories		
Photo ID: IMG-1005 (Canon SureShot A510, #S28099)

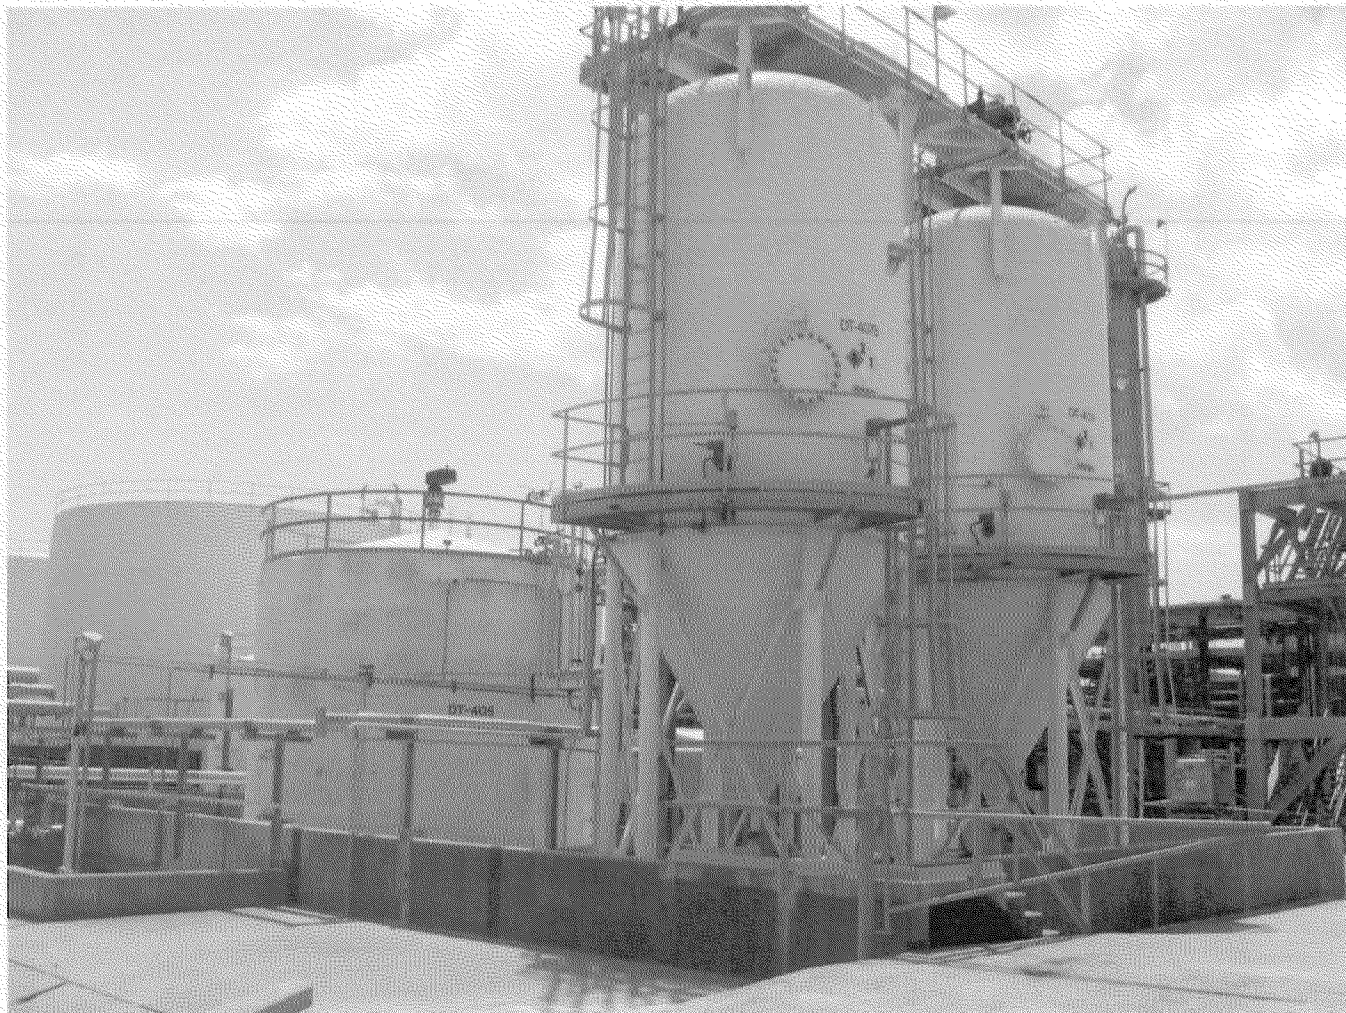
Official Photograph Log
Photo No. 6

- a. SWMU 1 is Hazardous Waste Tank DT405. This tank has not been used and was closed by TCEQ (see Attachment B, Photograph 6).
- b. SWMU 2 is Hazardous Waste Tank DT407A. This tank receives heavy ends products from the Chlor Alkali Plant; the heavy ends are sold as product to PPG in Louisiana (see Attachment B, Photograph 6).

- c. SWMU 3 is Hazardous Waste Tank DT407B. This tank receives heavy ends products from the Chlor Alkali Plant; the heavy ends are sold as product to PPG in Louisiana (see Attachment B, Photograph 6).

Photographer: Matt Brogger	Date: 8/21/12	Time: 1430 hours
City/County: Point Comfort, Calhoun	Direction (facing): Southwest	State: TX
Location: Formosa Plastics Corp.		
Subject: Tanks DT407A and 407B in Chlor Alkali Plant (SWMUs 2 and 3, respectively)		
Photo ID: IMG-1006 (Canon SureShot A510, #S28099)

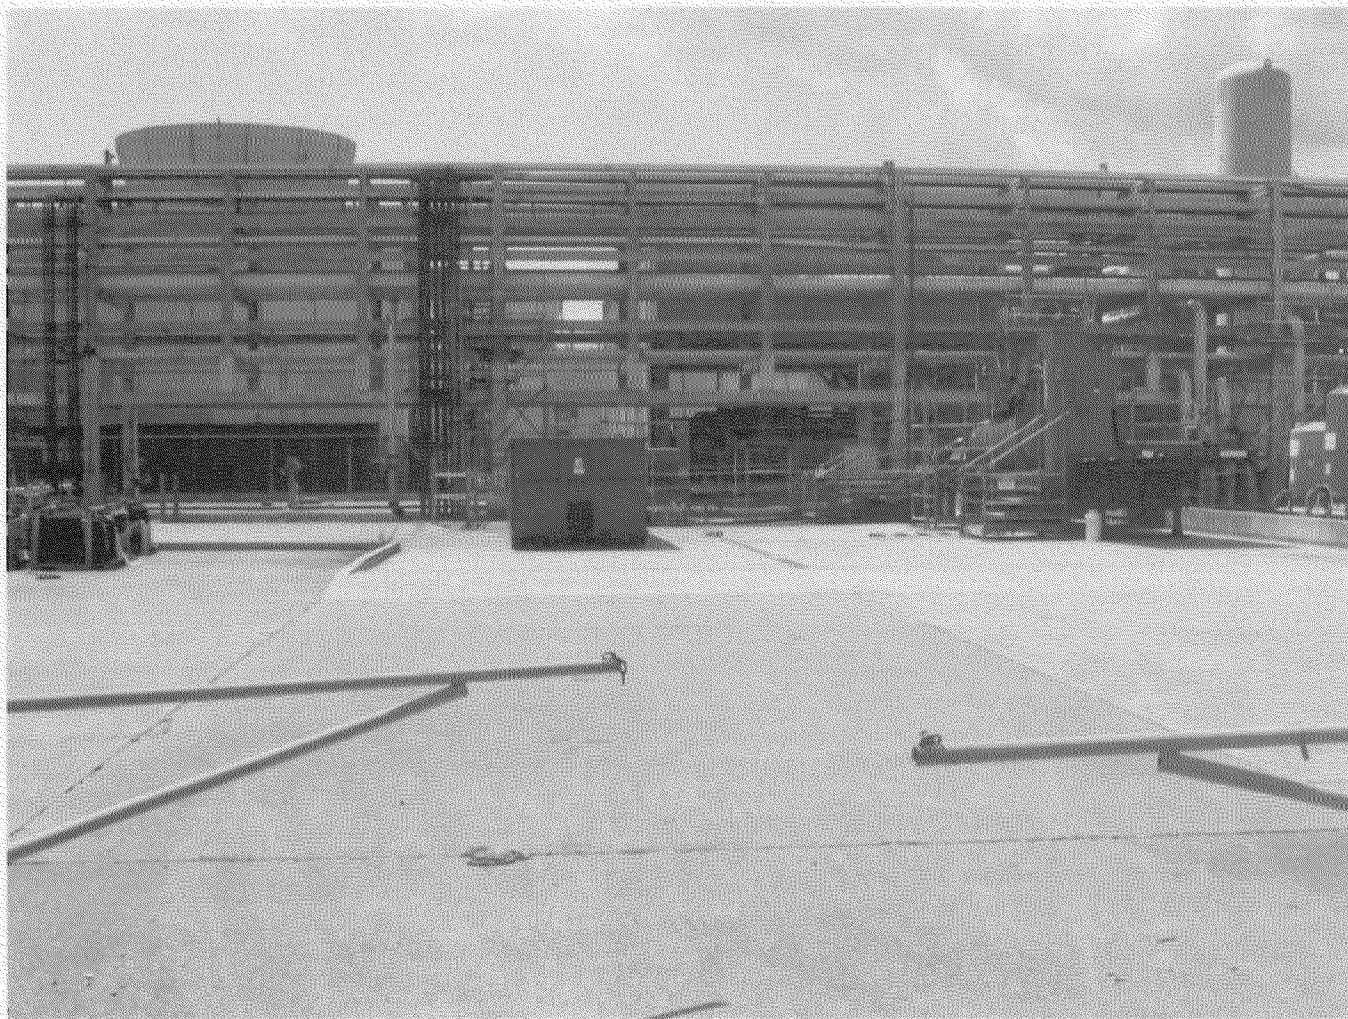
Official Photograph Log
Photo No. 7

- f. SWMU 6 is a CSA within the battery limits of the Chlor Alkali plant. The CSA is used to store roll-off boxes used for plant maintenance and repair activities. Once the roll-off boxes are full, the boxes are moved to the less than 90-day container storage yard in the pre-1991 area of the facility. At the time of inspection, there was one roll-off box containing scrap metal in the CSA (see Attachment B, Photograph 7).

Photographer: Matt Brogger	Date: 8/21/12	Time: 1435 hours
City/County: Point Comfort, Calhoun	Direction (facing): West	State: TX
Location: Formosa Plastics Corp.		
Subject: CSA in Chlor Alkali Plant (SWMU 6)		
Photo ID: IMG-1007 (Canon SureShot A510, #S28099)

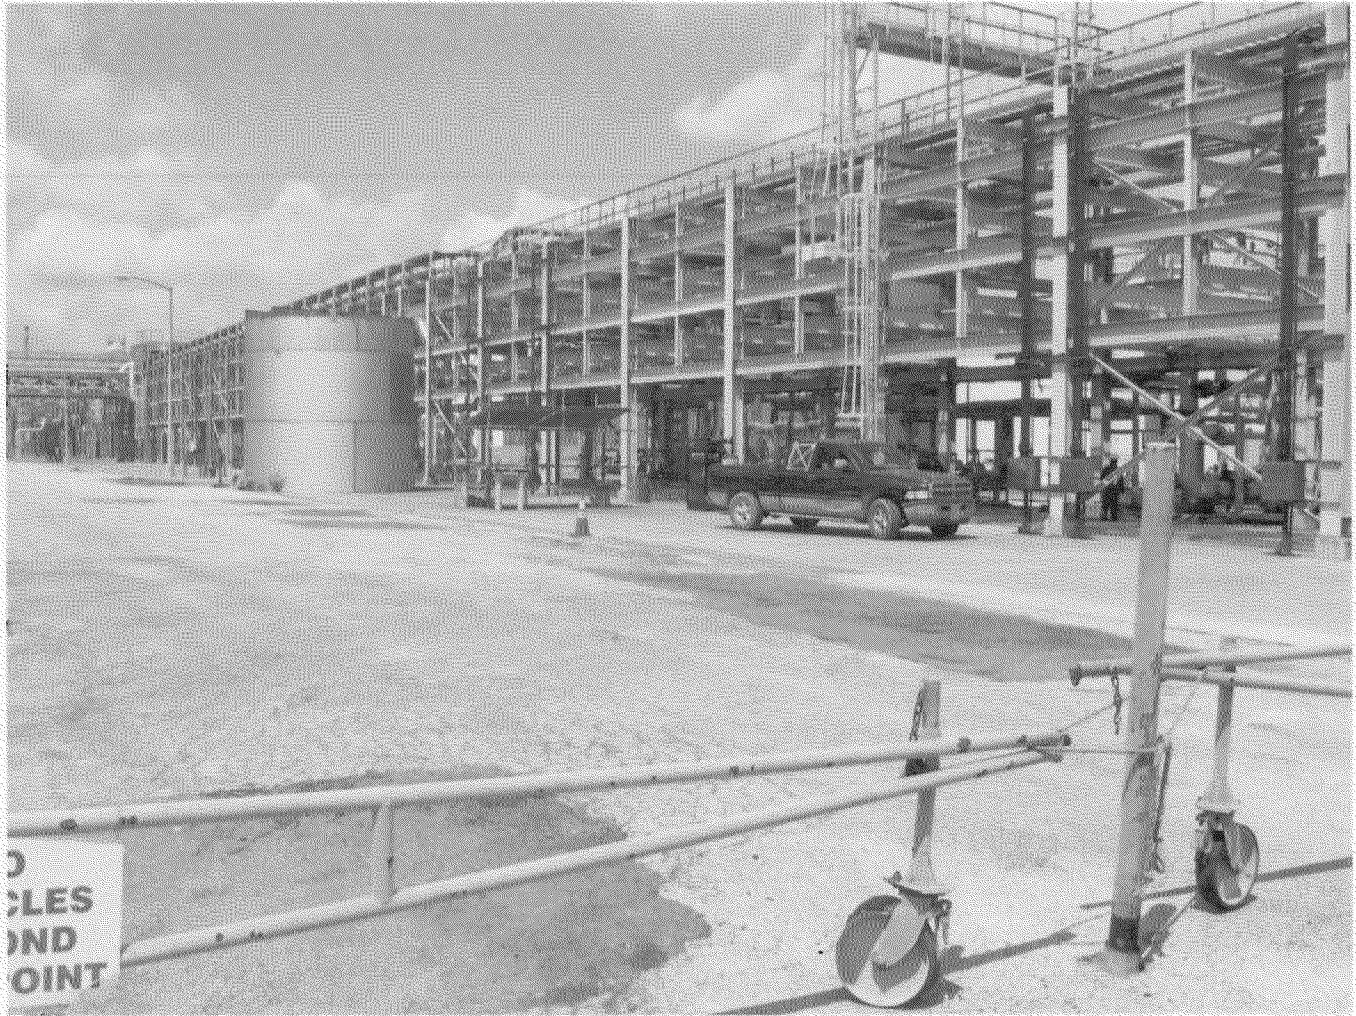
Official Photograph Log
Photo No. 8

Photographer: Matt Brogger	Date: 8/21/12	Time: 1448 hours
City/County: Point Comfort, Calhoun	Direction (facing): Northeast	State: TX
Location: Formosa Plastics Corp.		
Subject: CSA in Chlor Alkali Plant near EDC production line (SWMU 10)		
Photo ID: IMG-1008 (Canon SureShot A510, #S28099)

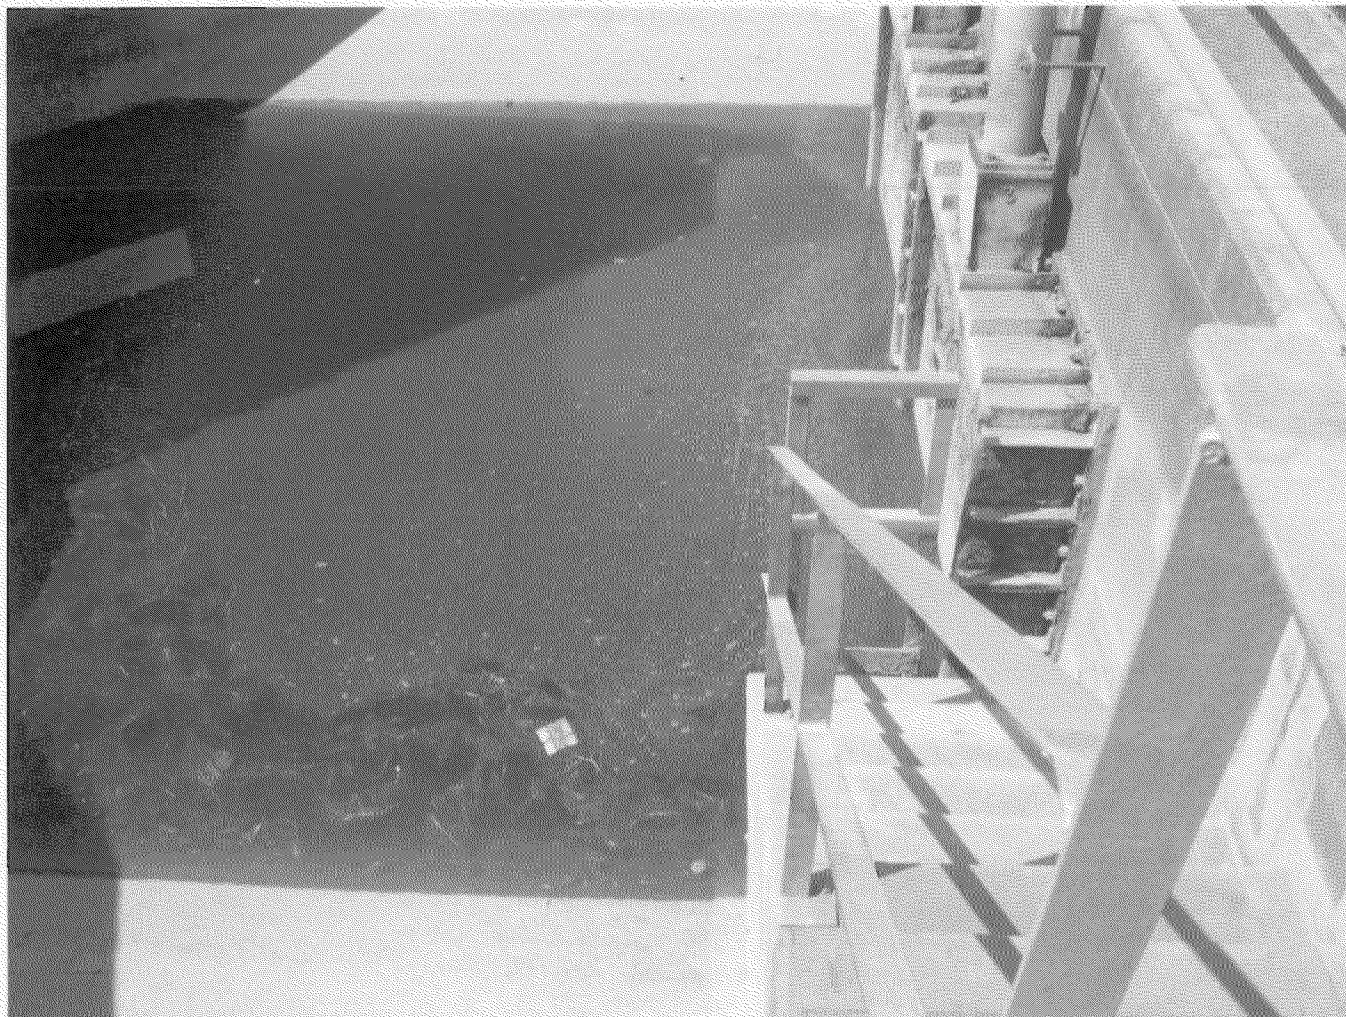
Official Photograph Log
Photo No. 9

- a. Outfall 006 is located immediately south of the CWTP and drains most of the southern end of the Expansion Area. At the time of the inspection, the stormwater outfall was cleaned of vegetative debris and solid waste (see Attachment B, Photograph 9). EPA observed minnows in the standing water above and below the outfall.

Photographer: Matt Brogger	Date: 8/21/12	Time: 1528 hours
City/County: Point Comfort, Calhoun	Direction (facing): Northwest (down)	State: TX
Location: Formosa Plastics Corp.		
Subject: Stormwater Outfall 006 (AOC 1a)		
Photo ID: IMG-1009 (Canon SureShot A510, #S28099)

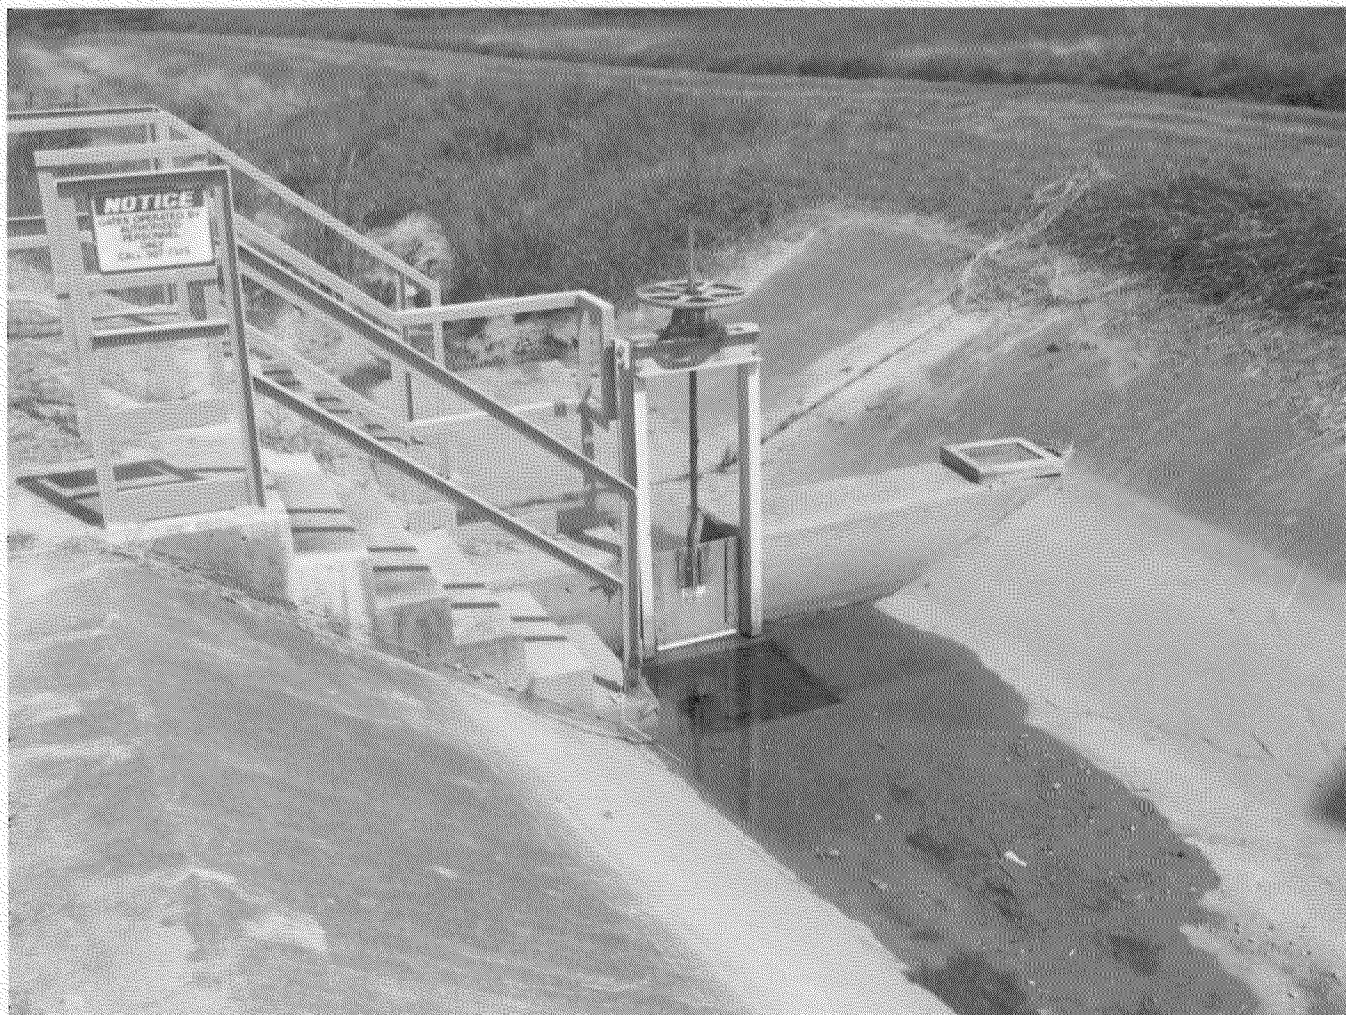
Official Photograph Log
Photo No. 10

Photographer: Matt Brogger	Date: 8/21/12	Time: 1536 hours
City/County: Point Comfort, Calhoun	Direction (facing): Northeast (down)	State: TX
Location: Formosa Plastics Corp.		
Subject: Stormwater Outfall 007 (AOC 1b)		
Photo ID: IMG-1010 (Canon SureShot A510, #S28099)

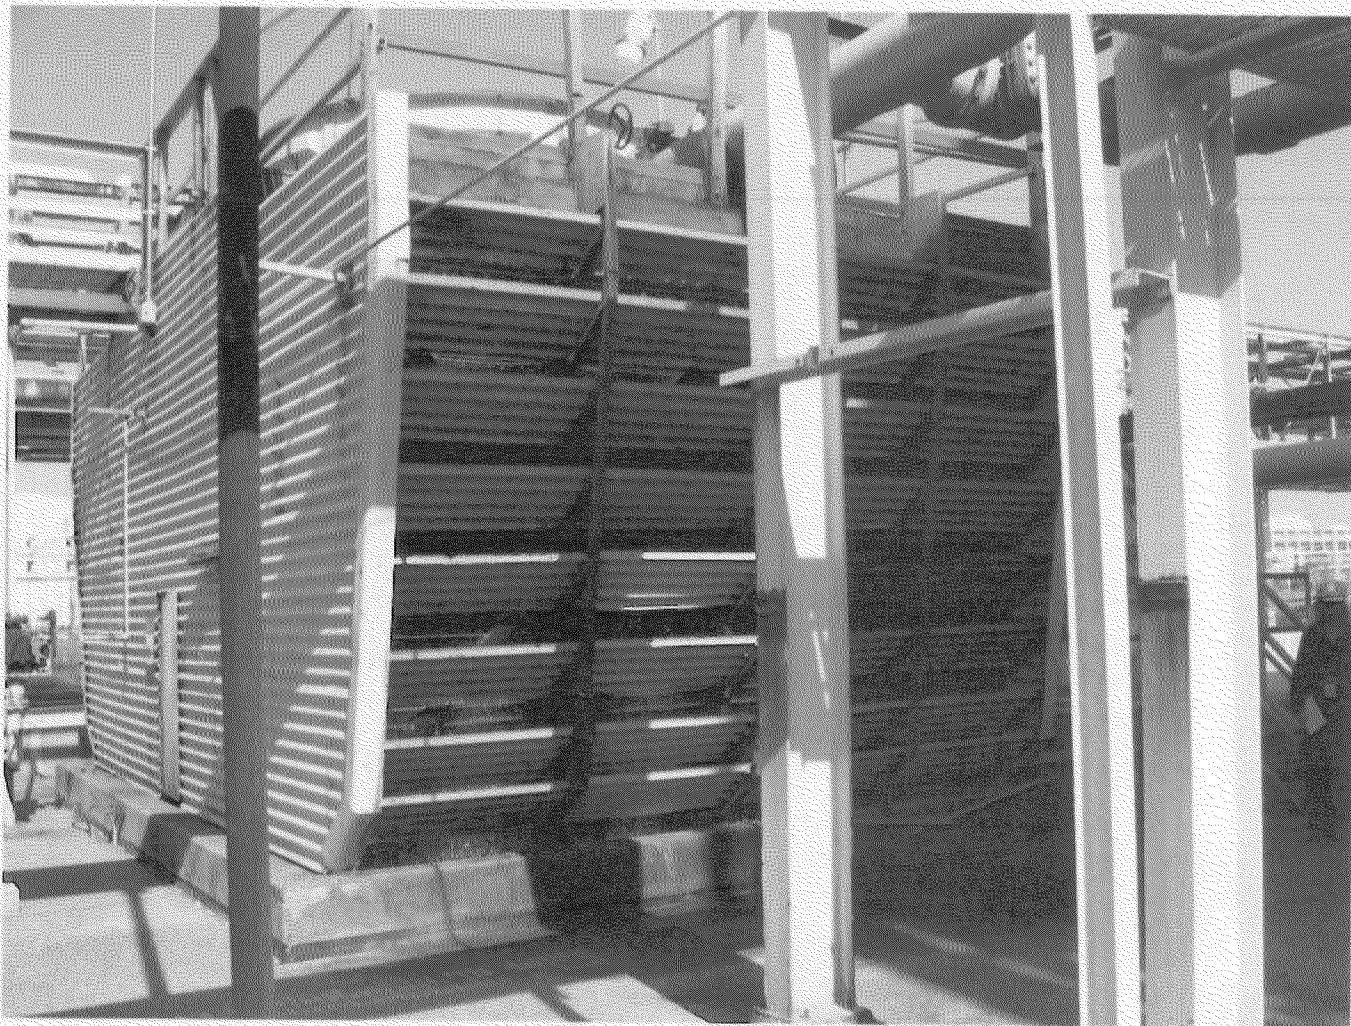
Photo No. 11

Photographer: Matt Brogger	Date: 8/22/12	Time: 0951 hours
City/County: Point Comfort, Calhoun	Direction (facing): Northwest	State: TX
Location: Formosa Plastics Corp.		
Subject: Brine chiller in Central Wastewater Treatment Plant (CWTP)		
Photo ID: IMG-1001 (Canon SureShot A510, #S28099)

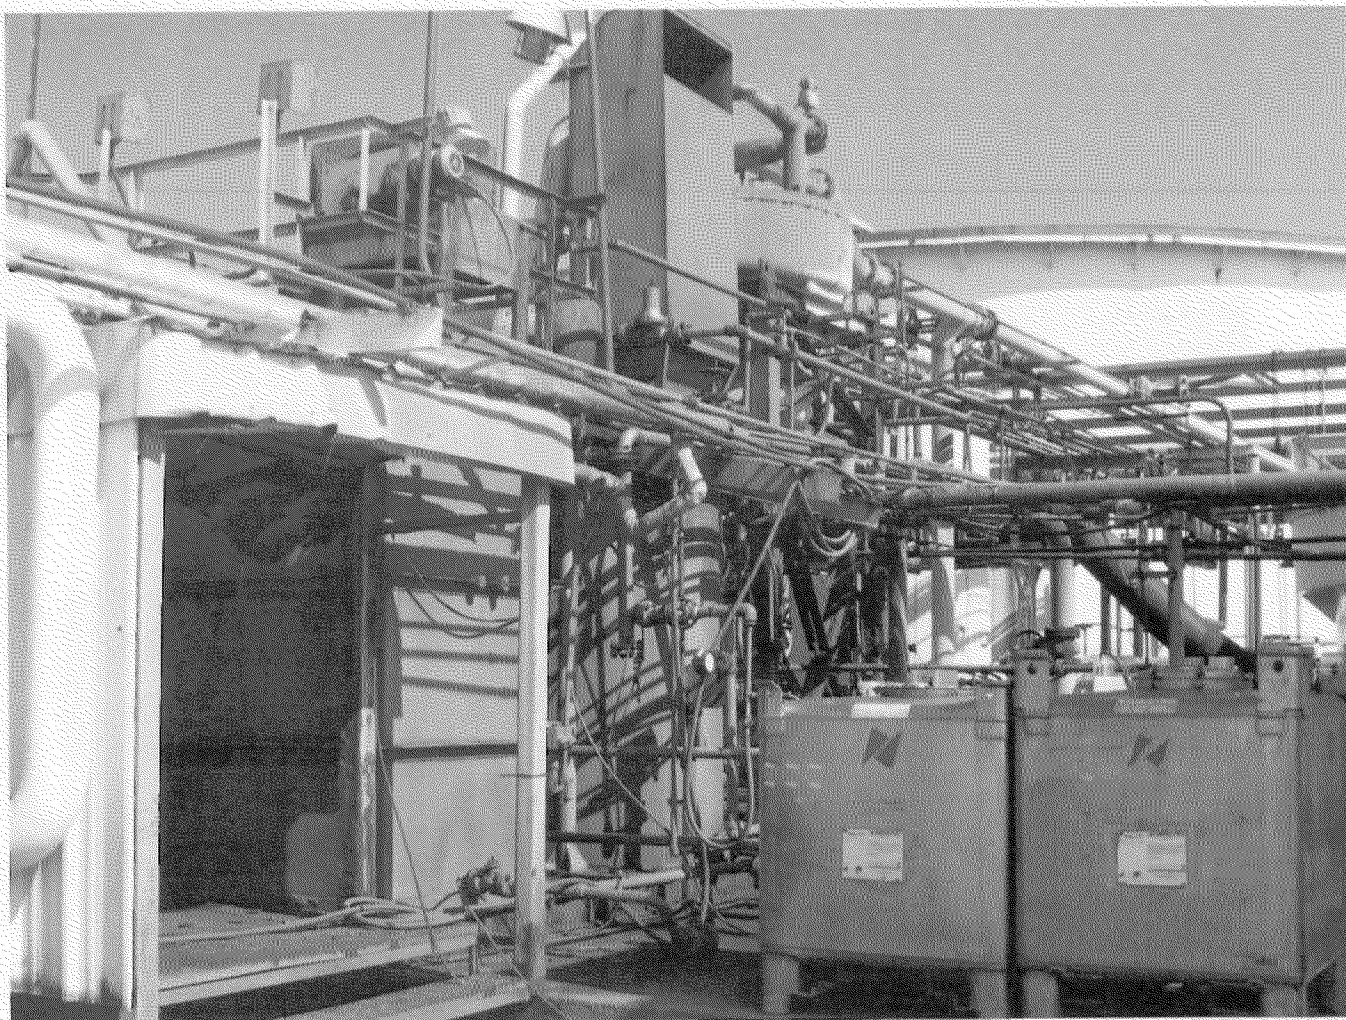
Official Photograph Log
Photo No. 12

- e. EPA inspected the copper compression unit. During the EPA inspection in 2010, this area had a discharge of copper sludge to the stormwater drainage system due to a pump failure. At the time of this inspection, the copper removal system was operating without incident (see Attachment B, Photograph 12).

Photographer: Matt Brogger	Date: 8/22/12	Time: 1015 hours
City/County: Point Comfort, Calhoun	Direction (facing): North	State: TX
Location: Formosa Plastics Corp.		
Subject: Copper compression unit at CWTP		
Photo ID: IMG-1002 (Canon SureShot A510, #S28099)

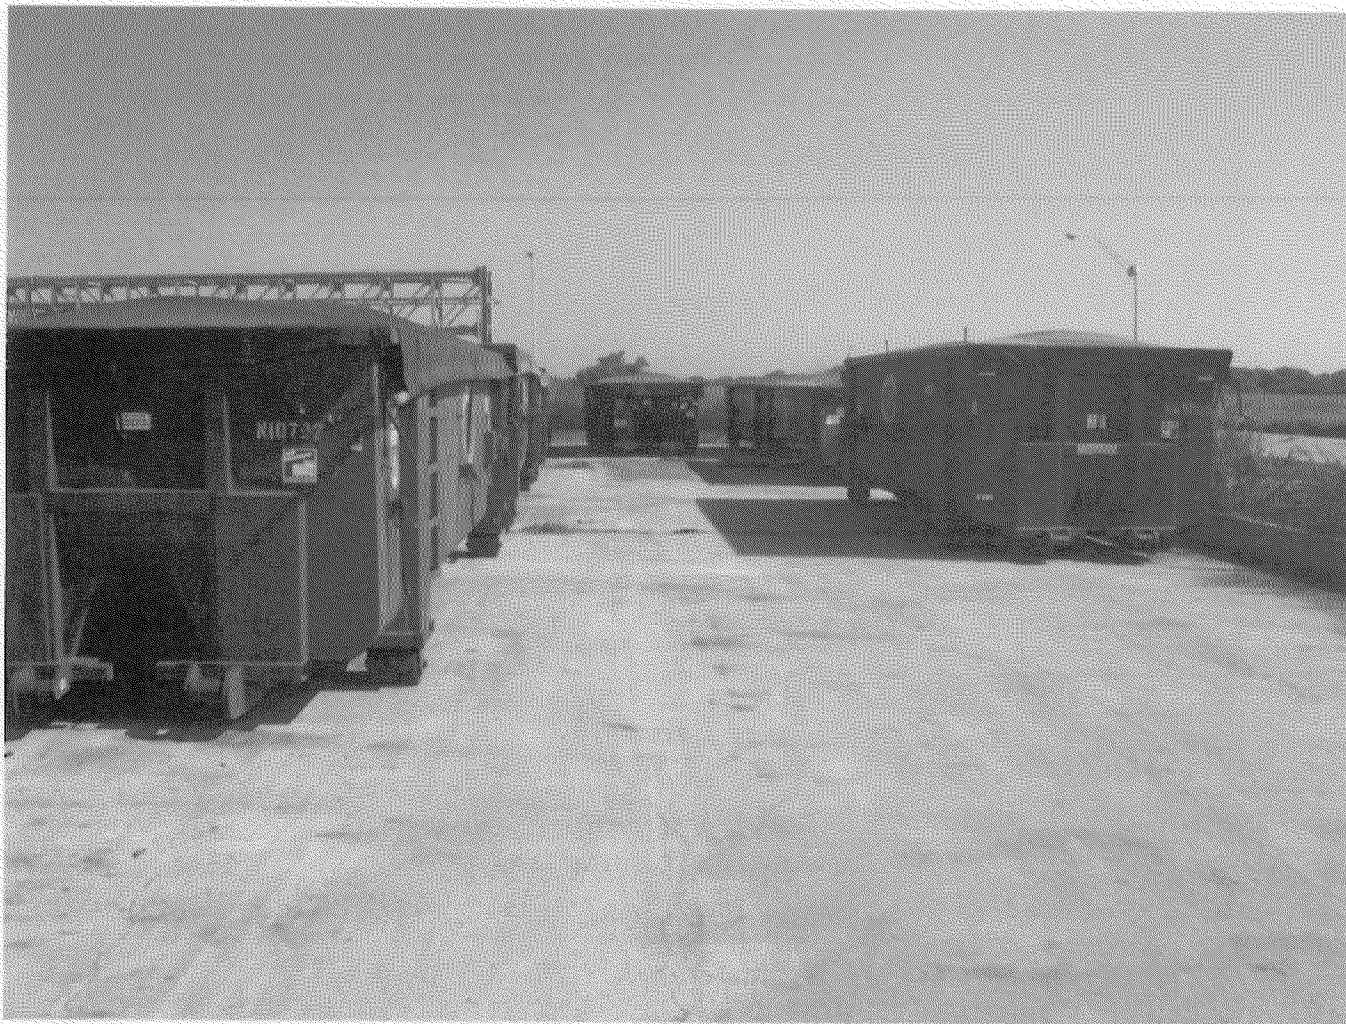
Official Photograph Log
Photo No. 13

Photographer: Matt Brogger	Date: 8/22/12	Time: 1020 hours
City/County: Point Comfort, Calhoun	Direction (facing): North	State: TX
Location: Formosa Plastics Corp.		
Subject: Roll-off box storage of solids from belt press in CWTP		
Photo ID: IMG-1003 (Canon SureShot A510, #S28099)

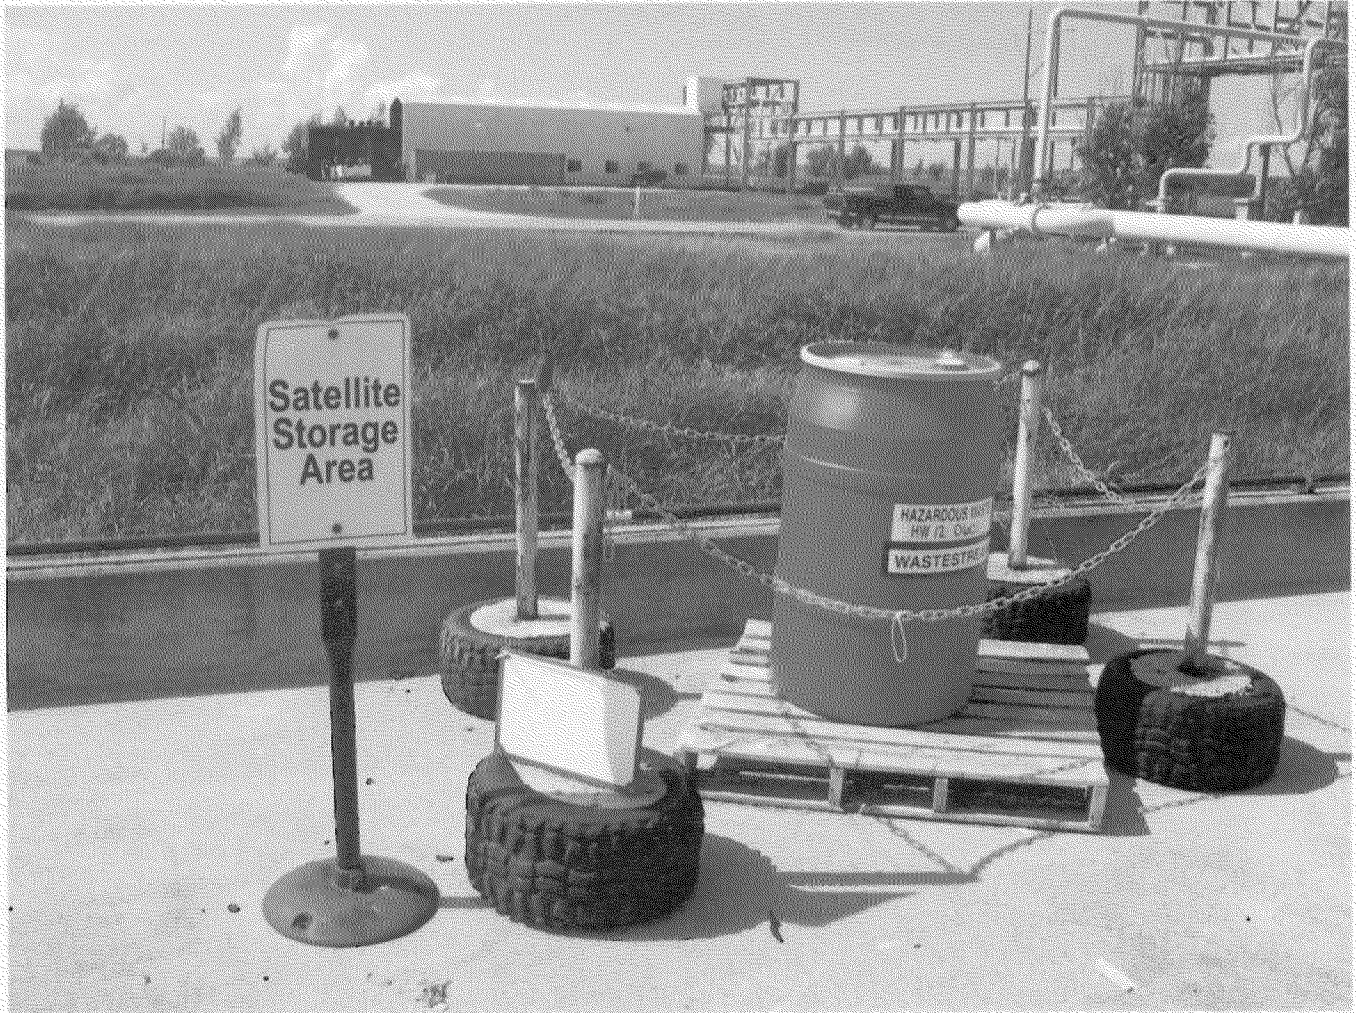
Official Photograph Log
Photo No. 14

- h. Immediately southwest of the mixing box, Formosa has established a satellite accumulation area for collection of hazardous waste sludges (see Attachment B, Photograph 14) generated when sludge from the mixing box is removed. The sludges are listed hazardous waste from the groundwater treatment system.

Photographer: Matt Brogger	Date: 8/22/12	Time: 1045 hours
City/County: Point Comfort, Calhoun	Direction (facing): South	State: TX
Location: Formosa Plastics Corp.		
Subject: Hazardous waste SAA at CWTP		
Photo ID: IMG-1004 (Canon SureShot A510, #S28099)
